# TRENCHLESS REHABILITATION OF WATER MAIN ASSET

## NUFLOW OTAGO

Borlasses Rd Water Main | Dunedin City Council

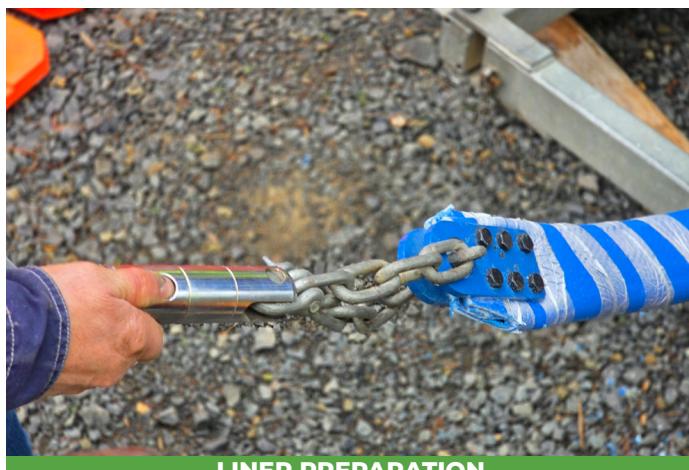
LINER PREPARATION

The 'W' Series ASOE liner was winched through the pipeline using a cable drum trailer. Care was taken to keep the liner straight and untwisted during installation. Once in place, it was inflated with air to press firmly against the host pipe, creating a tight, leak-resistant seal.

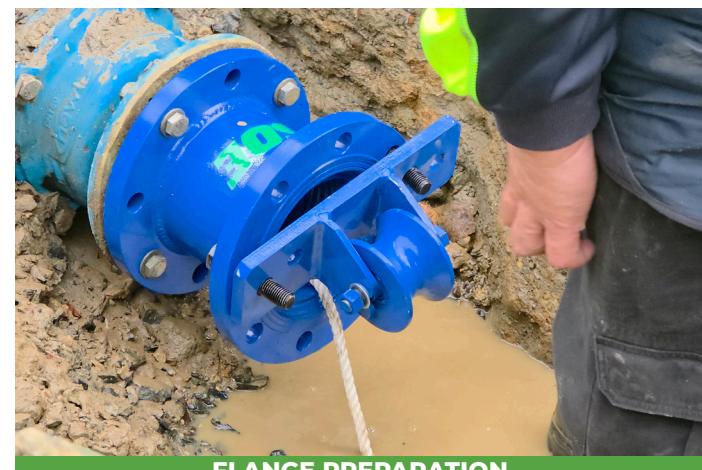
FLANGE PREPARATION

Access pits were excavated at both ends of the pipeline, exposing the existing cast iron/AC main. The pipe was cleaned and prepared for relining, and custom ASOE termination flanges were installed and securely anchored to provide a sealed interface for the liner.

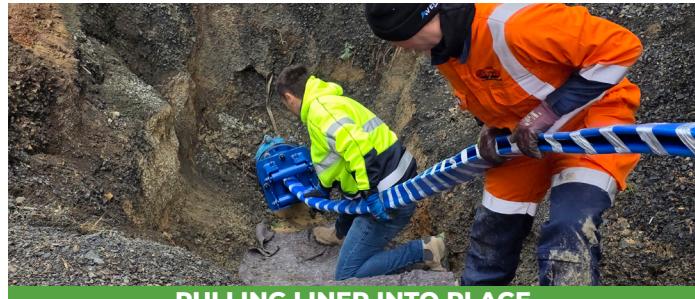
PULLING LINER INTO PLACE

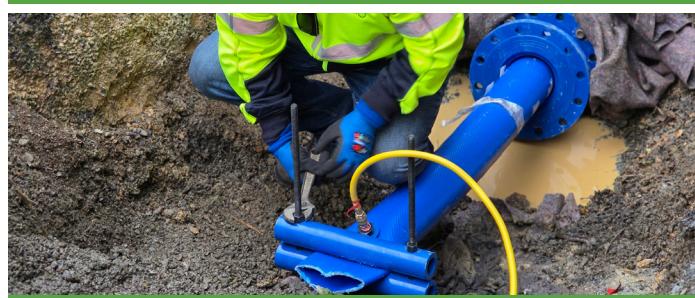
LINER CLAMP AND INFLATION

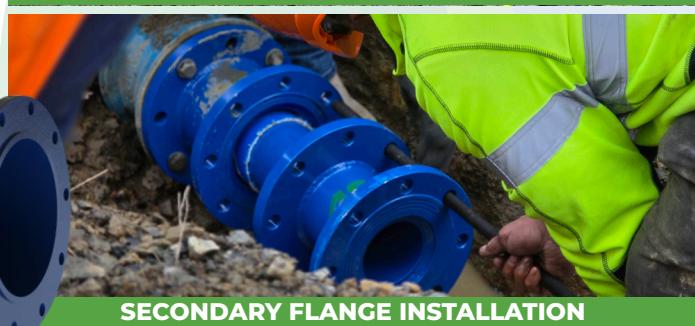
SECONDARY FLANGE INSTALLATION

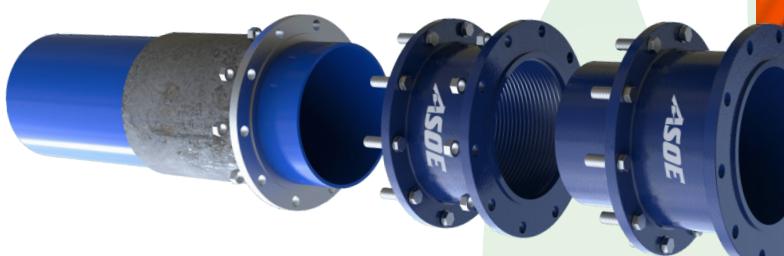
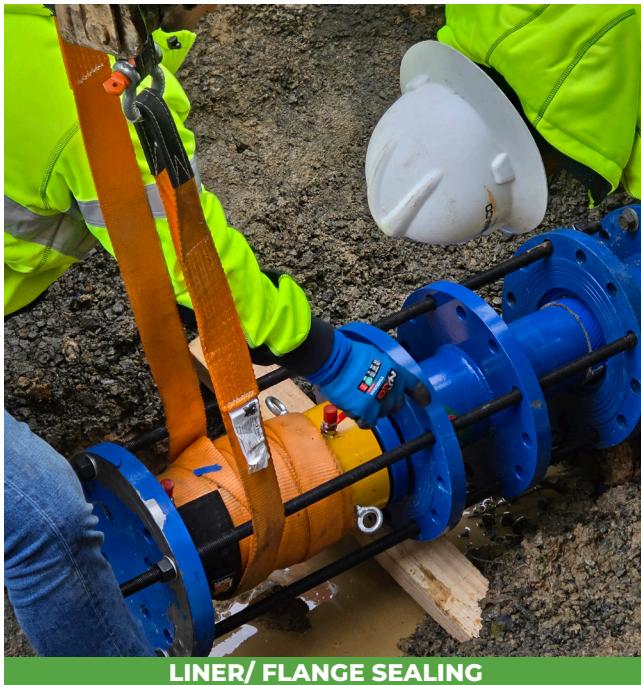
LINER/ FLANGE SEALING

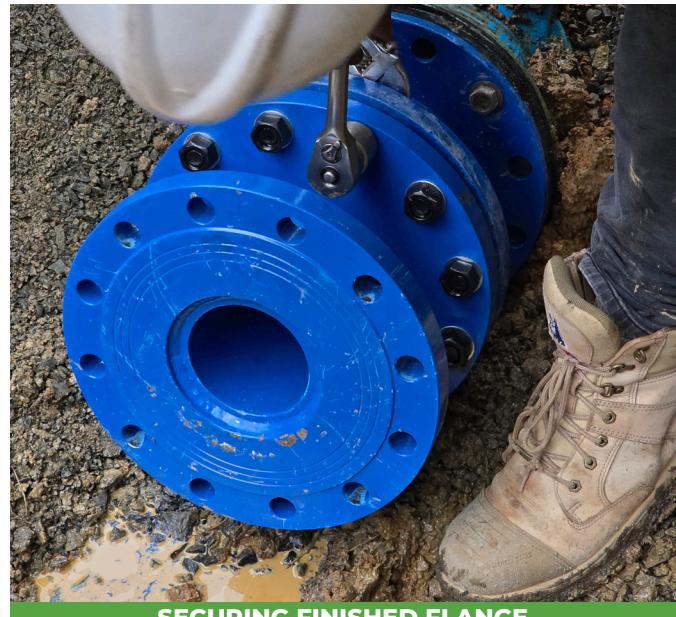
SECURING FINISHED FLANGE
